## Service Bulletin-33

# Analysis of Failed Vacuum Capacitors

Vacuum Capacitors  
**Failure Analysis Report**

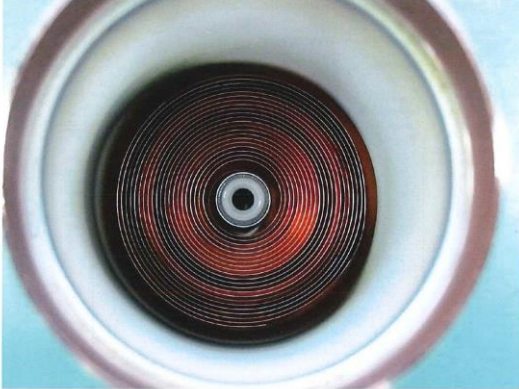
Picture 1: fixed electrode, intact with ceramic contaminated with vaporized metal due to plasma

<b>Inside of capacitor</b>	
Generally: oxidised	Bellows leak test: leak bellows - brazing joint
Ceramic: contamination with vaporized metal due to plasma	Bellows inside (visually): ok
Variable electrode: ok	Guiding tube: ok
Fixed electrode: ok	Shaft: ok
Bellows outside: ok

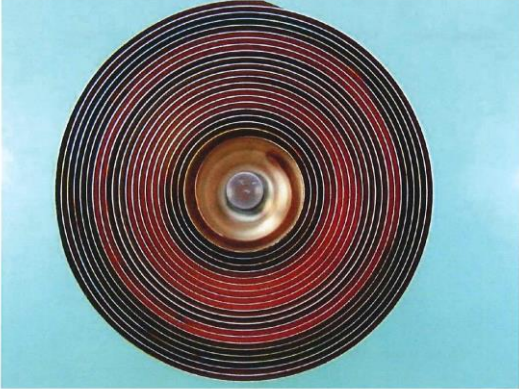
Picture 2: variable electrode, intact

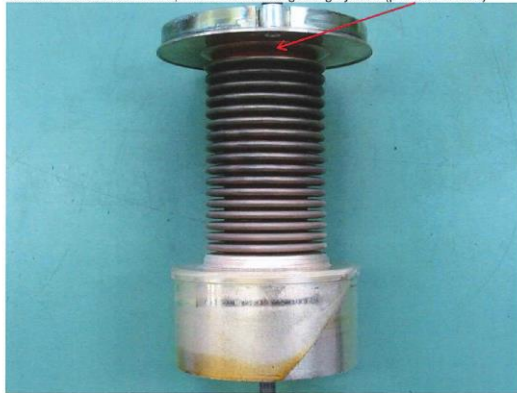
Picture 3: variable electrode, with bellows and guiding system (position of leak)

**Analysis**  
The primary reason for the failure of the capacitor was a fatigue crack at the brazing joint from collar to bellows. This caused loss of vacuum and consequently led to the failure observed. No evidence has been provided about operational conditions and operating hours.

**Corrective Action, Recommendation**  
The capacitor cannot be repaired. No replacement on warranty, analysis will be charged.
